## **PANEL 7 etc.**

.. appendix for summer letter to the Yahoo JR group, dated 20080715

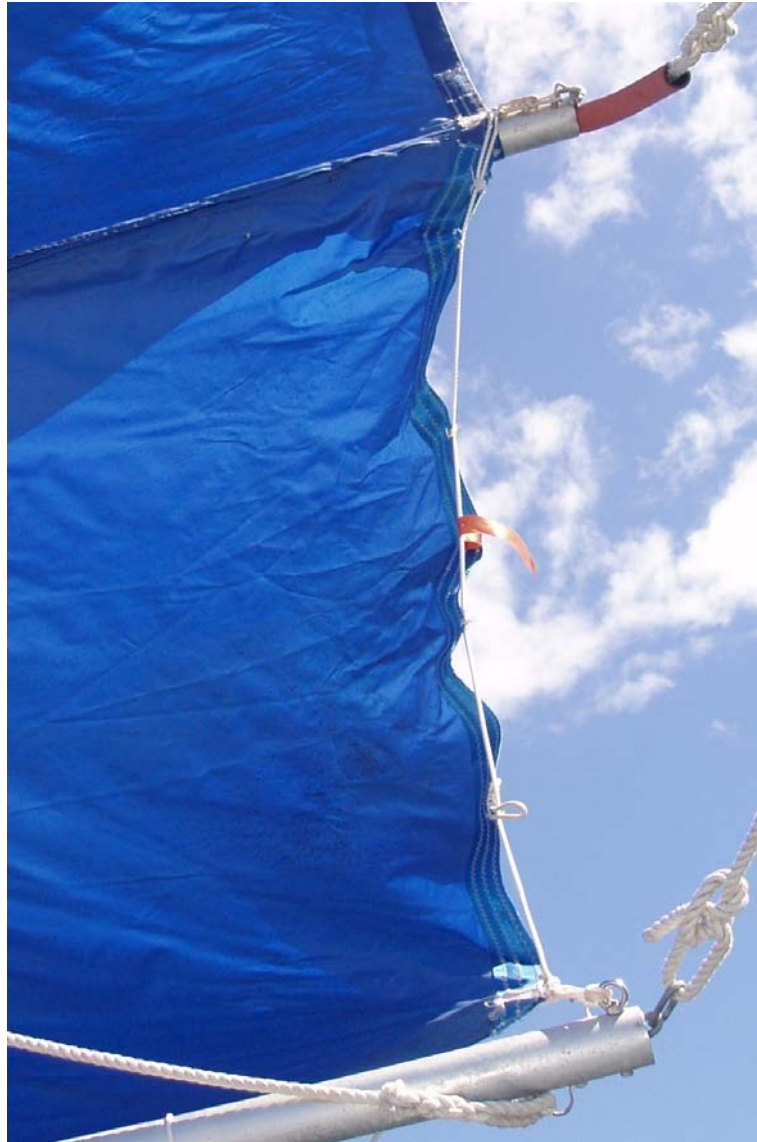
The shock chord at the leech of panel 7

The wind on the photo above was only about F3, so the boom has only lifted a bit. The shock chord has just taken in a bit slack.

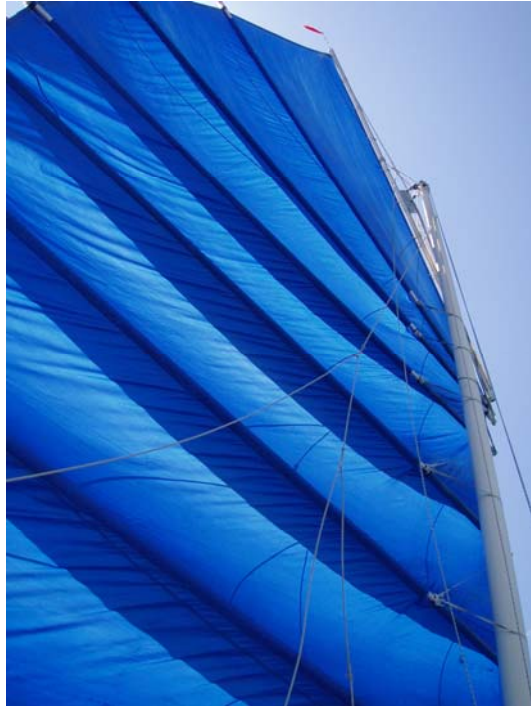
**Johanna's sail today at F3, setting well.**

Even when close-hauled there was not enough down-haul from the sheets to cause big wrinkles.

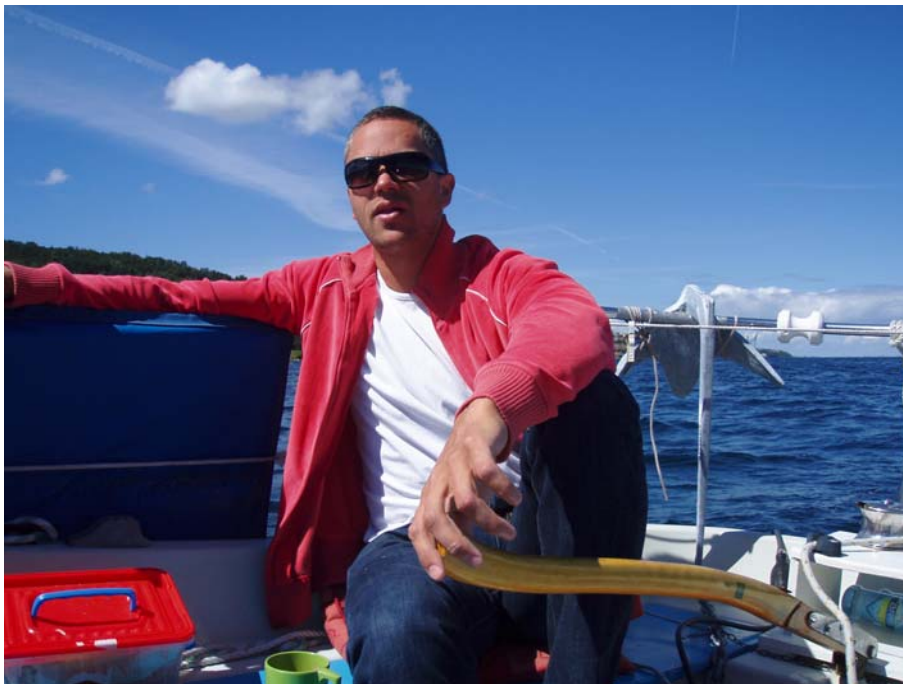
**Crew, Håvard wrestling with the tiller...**

This photo is not arranged in any way. The tiller, controlling the semi-balanced rudder is indeed light.
